**SPOTLIGHT: COOLANTS/LUBRICANTS/FILTERS**

## **'Breaking News' Was Not a Good Thing for a Broach Maker**

**As coolants broke down, problems with its grinding operation rose**

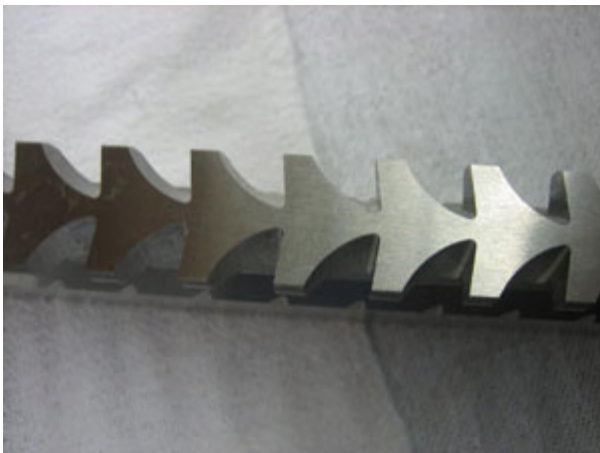
**By switching to mineral oil-based NuSol, GBC reduced coolant consumption by 30 percent in grinding broaches**

NuSol was also less expensive for GBC because operators did not have to continuously add coolant into the systems. The company reduced coolant consumption by 30 percent because it did not dump its sumps as often and it used less make-up coolant concentrate on a daily basis. *Chemtool, Inc.*
